Technical Paper

Session: 41-2

Hard particle contamination in reciprocating compressors

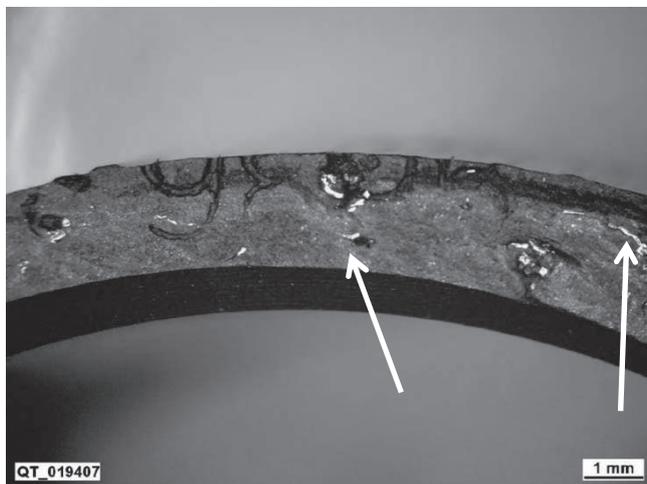
Figure 5 shows a piston ring from a hydrocarbon compressor, which suffered from extreme cylinder liner wear with clear metal particles embedded. Using scanning electron microscopy with energy dispersive X-ray spectroscopy (SEM/EDX) it was possible to determine the chemical composition of the particles embedded on the ring surface (Figure 6) which was Al_2O_3 .

Figure 5 – Piston ring with embedded metal particles.

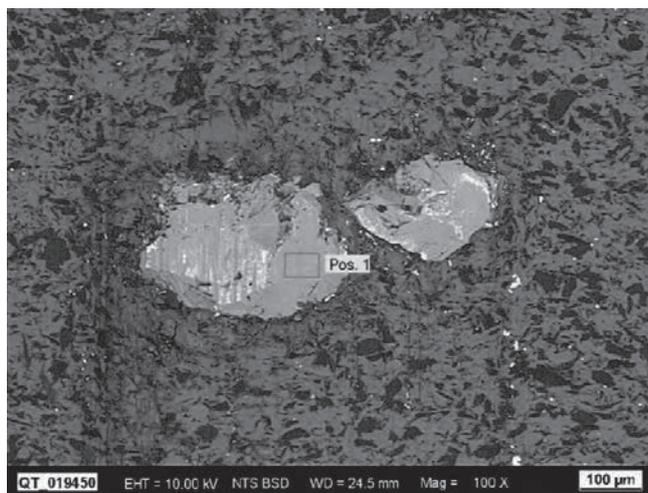
Figure 6 – SEM micrograph of Al_2O_3 particles embedded in piston ring.

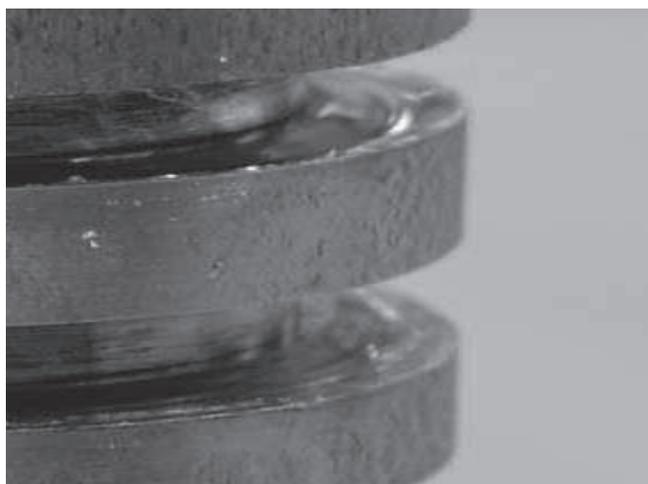
Figure 7 – Piston ring groove wear

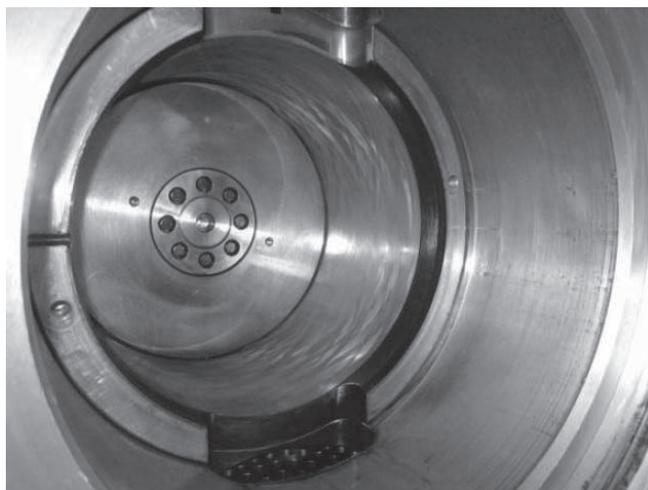
Figure 10 –WC coated liner after 6000hrs of operation

Figure 10 shows a cylinder liner coated with WC-Co after 6000 hours in operation. Other sprayed coatings can be used such as Cr_xO_x and other ceramic ternary alloys [6]. The state of the art solution considered is proprietary bi-metal hot isostatic process of the cylinder liner with diameters smaller than 200 mm. This implies a solid base body encapsulated (outer surface) and inner body (powder form) to be processed by hot isostatic press. This combines the benefit of different material properties with a high quality uniform microstructure with a diffusion type bonding without segregations. In the case of suspicion of a particle contamination has occurred proactive and open communication between OEM and End user/operator is required. In such cases focus on well documented information is crucial. The material investigations should be properly structured using experienced certified laboratories according to ISO/IEC 17025.
