SUCCESS STORY

COMPRESSOR FRAME AND BASEPLATE REPAIRED IN PARALLEL TO SAVE TIME

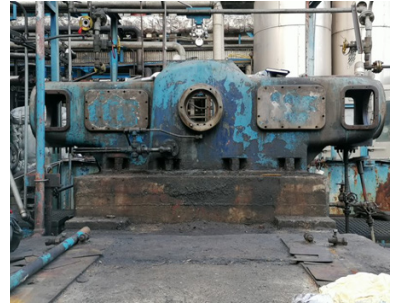
- Damages on frame: crankshaft, main bearing housing and cylinder
- Cracks in baseplate
- Very short timeframe for repair including holiday season at end of year

Old compressor frame on site before repair

- Burckhardt Compression Italy submitted a full repair procedure
- Repair of main bearing housing on frame and crankshaft executed at Burckhardt Compression Service Center in Germany
- Supply of connecting rod bearings and repair of crosshead
- Sandblasting of two cylinders to restore sealing surfaces
- Compressor reassembly in workshop
- Renewal of baseplate on site
- Compressor start-up with Burckhardt Compression experts on site
- Supply of spare parts for customer's stock

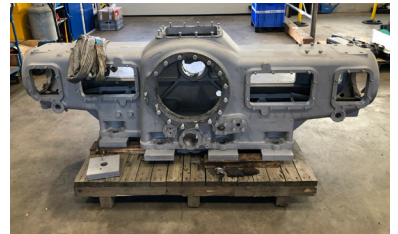
Frame after sandblasting

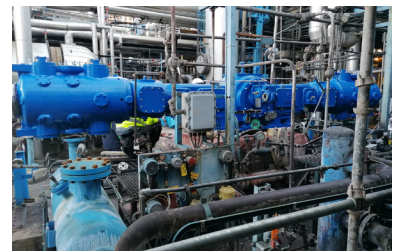
Repaired compressor being installed on site
