## **SUCCESS STORY**

### **RE-ENGINEERING OF OTHER BRAND COMPRESSOR CYLINDER WITHIN TIGHT TIME FRAME**

### Cylinder repair of third-party oxygen compressor

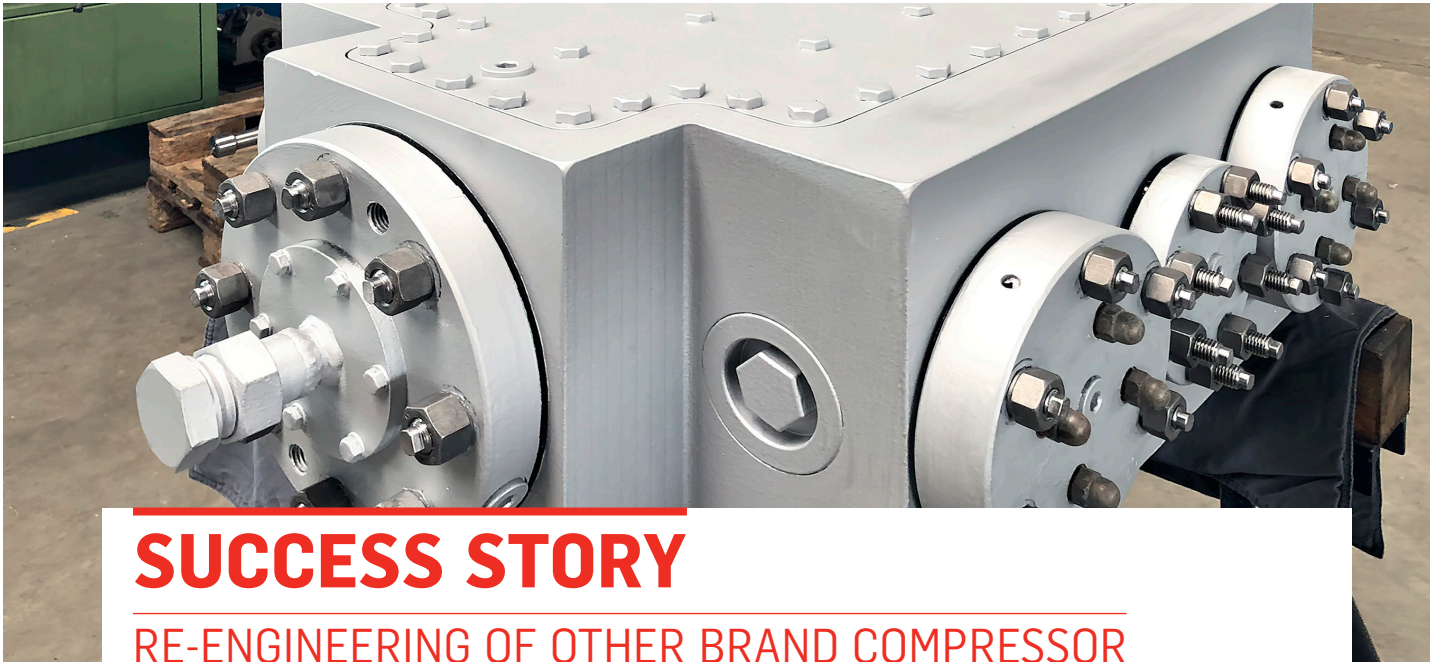
Old cylinder before repair at Burckhardt Compression Germany's Service Center

New cylinder in installed condition

- Reverse engineering of existing cylinder carried out by local team
- Upgrade cylinder design and material in order to add a built-in cylinder liner
- Project management
- On-site assembly with support from our local Field Service Representative
