SUCCESS STORY

OPTIMIZED ENERGY EFFICIENCY AND FEWER EMISSIONS AFTER COMPRESSOR REVAMP

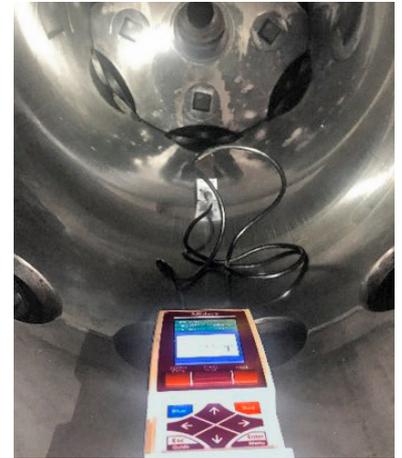
Proper surfaces roughness is critical. Thorough analyses showed that the surface of the cylinder liner was too smooth.

- Profound compressor system integrity analysis carried out by our experts onsite
- Analysis showed that the cylinder liner was damaged due to inappropriate piston ring material
- Recommendations made based on the analysis
- Upgrade of piston/packing rings to Persisto® 850, a material that has been specially developed for sealing applications in dry-running reciprocating compressors
- Repair of piston rod, applying proper coating material and roughness
- Refurbishment of packing and all other components at our local Service Center

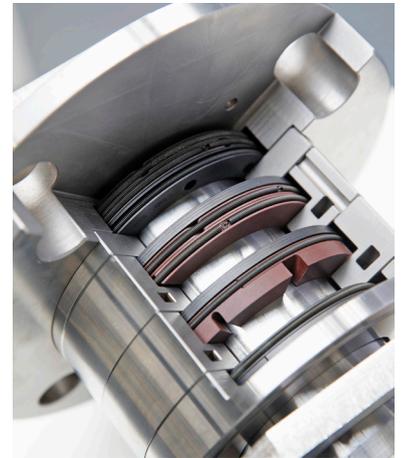
Piston and packing rings were upgraded to Persisto® 850, a material specially developed for dry-running applications.
