Technical Paper

Session: 41-2

Hard particle contamination in reciprocating compressors

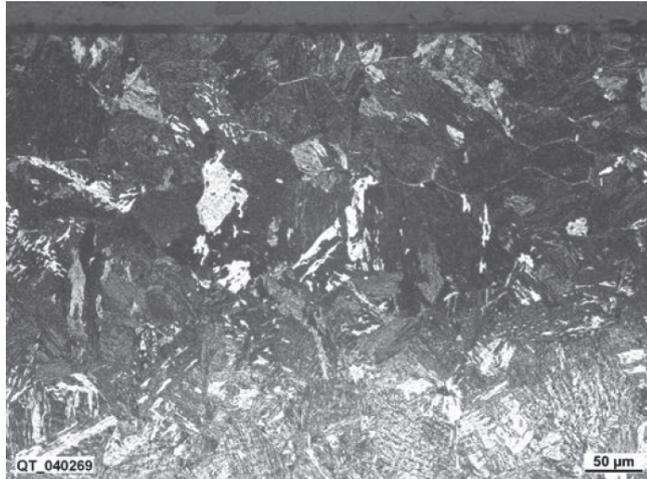
Figure 4 – Typical microstructure of 34CrAlN7 – etched condition.

Figure 3 shows a bearing grade PEEK microstructure. The cylinder liner material can be made out of 34CrAlNi7, in Gas nitrided condition. Gas Nitriding is a ferritic thermochemical treatment in which nitrogen is diffused into a steel surface at a temperature between 480-570 °C. After nitriding, a thin compound layer known as white layer is formed at the surface, which is composed of iron nitrides. The thickness of the white layer is typically between 5-30 μm. This formation of this layer is actively controlled by heat treatment process. To prevent the white layer from spalling during operation, the white layer needs to be mechanically removed [4]. The motivation to nitride cylinder liners is mainly to improve the surface hardness and wear resistance, with a reduced risk of scuffing and galling. A typical micrograph of nitride surface is shown in Figure 4.

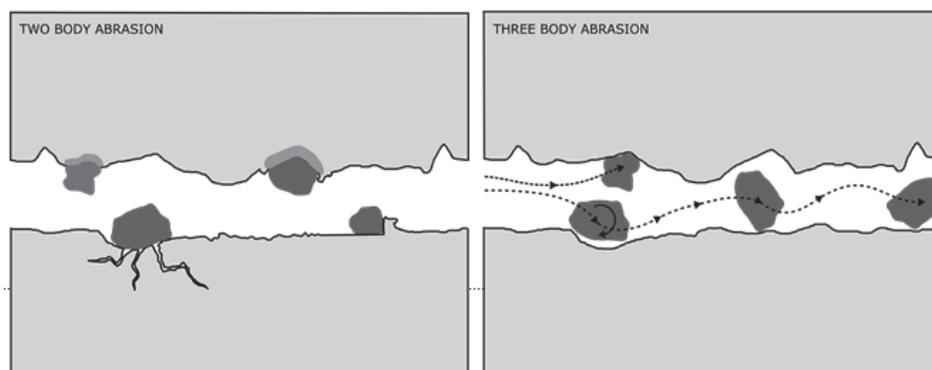
Figure 9 – Two and Three-body abrasion wear.

The nature of abrasive wear is given by the interaction between the external particle and the surface, i.e two-body and three-body abrasive wear. In simple terms for the case of polymer based piston ring vs a metal cylinder liner. The rigid external particles are held by the soft polymeric matrix acting in a similar manner as a cutting tool, as shown in Figure 9, left side. In a three-body the external particles are not held on the polymeric matrix and are free to roll and slide over the surface, Figure 9, right side. The abrasion is mainly dependent of the hardness ratio between the particle and the surface. If the ratio is higher than 1.2, then plastic indentations are produced on the surface, hence hard, fast abrasion. If the hardness ratio is below 1.2 there is no plastic indentation on the surface [5]. The shape and size of abrasive particles is also of great importance. Angular particles cause much more severe wear then rounded particles. Furthermore, particles with sharp edges cause more abrasion than round particles. Large particles can produce high values of abrasive wear. For high wear rates, a constant flow of hard particles needs to be introduced in order to create such amount of wear in
