SABIC, a global leader in diversified chemicals, operates three LDPE lines at their plant in Geleen, The Netherlands. After the successful compressor overhaul of one line in 2017, Burckhardt Compression was awarded another major overhaul order for the second line. The booster/primary compressor (Ingersoll Rand) and the Hyper Compressor (Burckhardt Compression) have been in operation for over 40 years.

APPLICATION DESCRIPTION

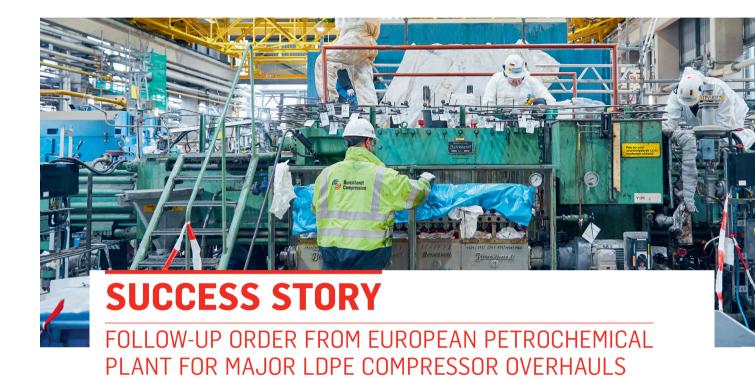
Machining of the booster.

Complete compressor disassembly on-site and crankcase removal Repair of 44-year-old foundation according to our procedures Repair works (machining) in local Service Center New lubrication piping made in-house
